## FIRE SEPARATION

### ISSUE

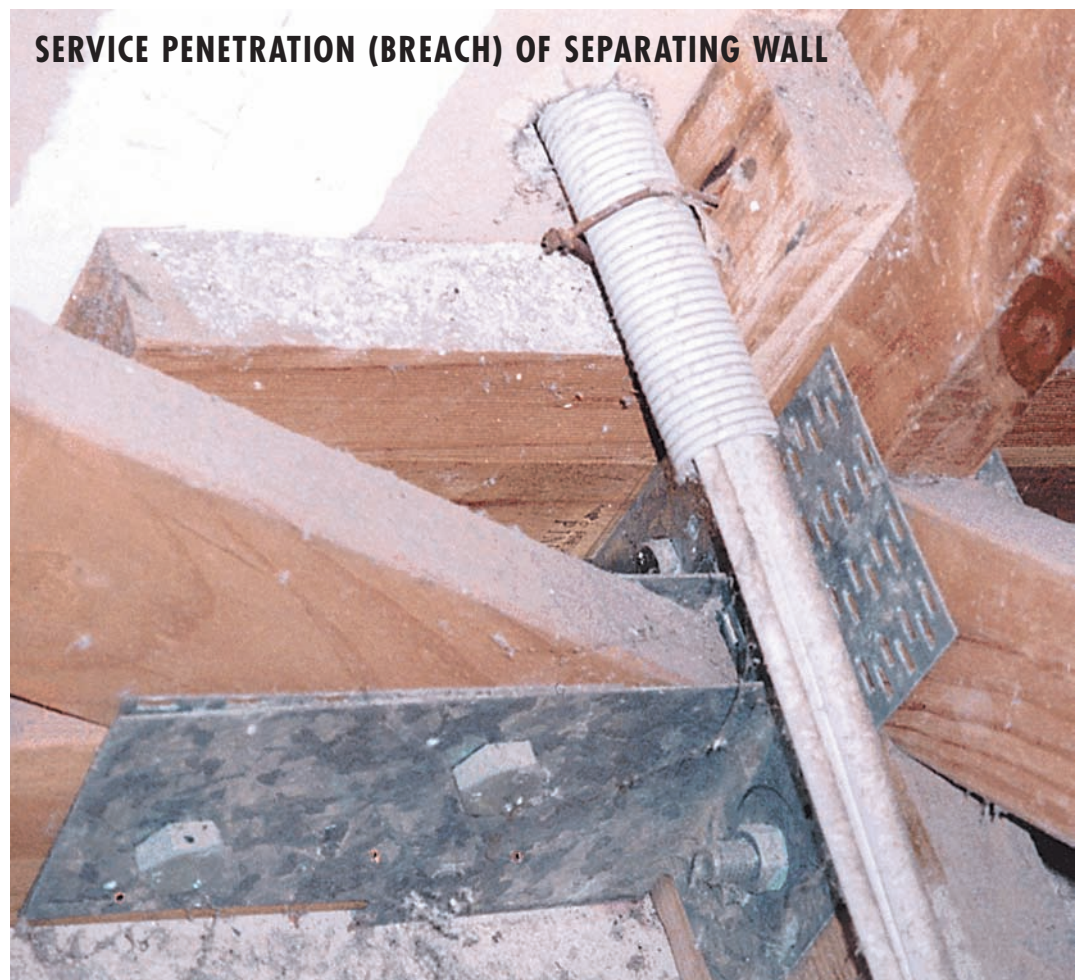
The Building Services Authority (BSA) is receiving an increasing number of complaints over fire separation walls in town houses and multiple dwellings. Investigations by BSA Inspectors have revealed that the construction of separating walls for fire protection is commonly falling well short of that prescribed by the Building Code of Australia (BSA) and manufacturer's specifications.

- Binders for trusses being carried through fire separating walls
- Numerous penetrations being made through separating walls with little consideration given to protection
- Separating walls not being carried through to the underside of roof sheeting
- and packed with an appropriate fire resistant material to manufacturer's specifications
- Gaps not being packed between separating walls and masonry veneer walls
- Inadequate protection to roof spaces of eaves, verandahs and similar spaces that are common to more than one unit/dwelling

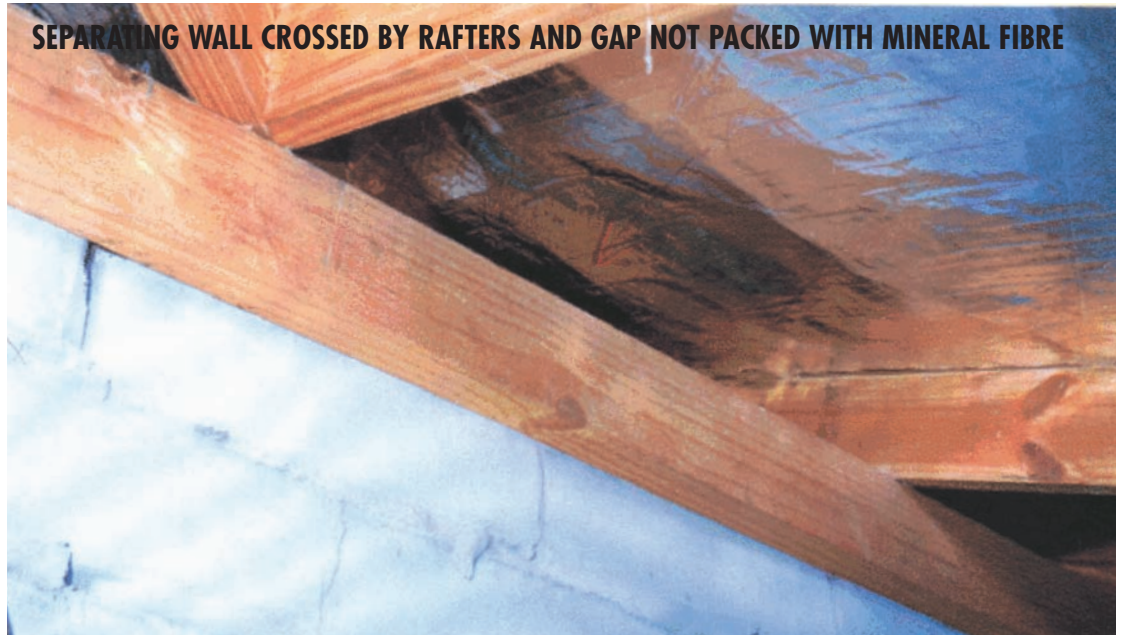
### SEPARATING WALL CROSSED BY RAFTERS AND GAP NOT PACKED WITH MINERAL FIBRE

Many building contractors have overlooked the attention to detail of approved building plans, specification and manufacturer's specification when constructing separating walls.

One main reason that appears to be apparent is that contractors do not have an understanding of the requirements of the BCA.

Class 1 dwellings must have a fire-resistant level (FRL) of not less than 60/60/60 and commence at the footings and extend to the underside of a non-combustible roof covering.

This separating wall must not be crossed by timber or other combustible building elements except for roof battens with dimensions of 75 x 50 mm. Any gaps between the top of the wall and the underside of the roof covering packed with mineral fibre or other suitable fire-resistant material.
